**DOT/FAA/AR-99/34**

# **Characterization of Early Stages of Corrosion Fatigue in Aircraft Skin**

## **Phase II: Interpretation of Corrosion-Fatigue Fracture Surfaces in Alclad 2024-T3 Aluminum Alloy Sheet**

Phase II Report

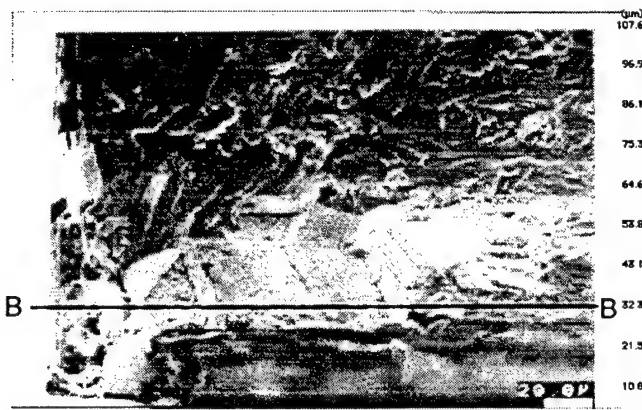
(a) SEM Micrograph Showing the Line of Sectioning.

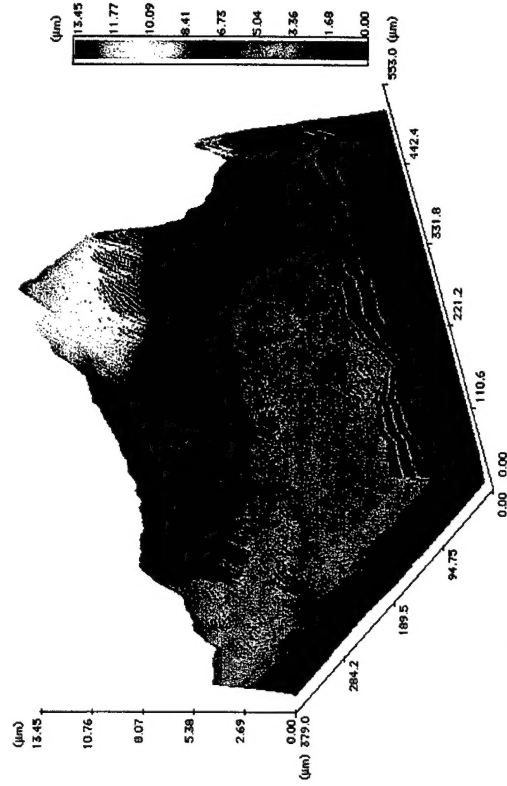
(d) Perspective View of Fracture Surface

FIGURE A-1. FATIGUE FRACTURE SURFACE OF A HIGH-STRENGTH STEEL TESTED IN SEA WATER SHOWING A MIXTURE OF INTERGRANULAR AND TRANSGRANULAR AREAS.
